# **Proposed Brosnan Forest Restoration Project Coldwater Branch Stream Mitigation Bank**

Norfolk Southern Railway Company - Brosnan Forest

**Project Purpose and Mitigation Plan:** We propose to expand the restoration of the large pocosin wetland established as the Brosnan Forest Mitigation Bank (BFMB) to the historical discharge creek known locally as Coldwater Branch (Figure 1). Effectively it is a large ditch extending about 4 miles northeast from the east side of the pocosin, eventually crossing under US Highway 78 and leaving Brosnan Forest property about 1 mile north of the road (Figure 2). The stream joins the last major tributary of the Four Hole Swamp drainage (Figure 4) in its southern (lower) end, and we propose to use the Four Hole Swamp basin (8-digit HUC 3050205) as the service area for this stream bank (Figure 3). Some residual wetland pockets

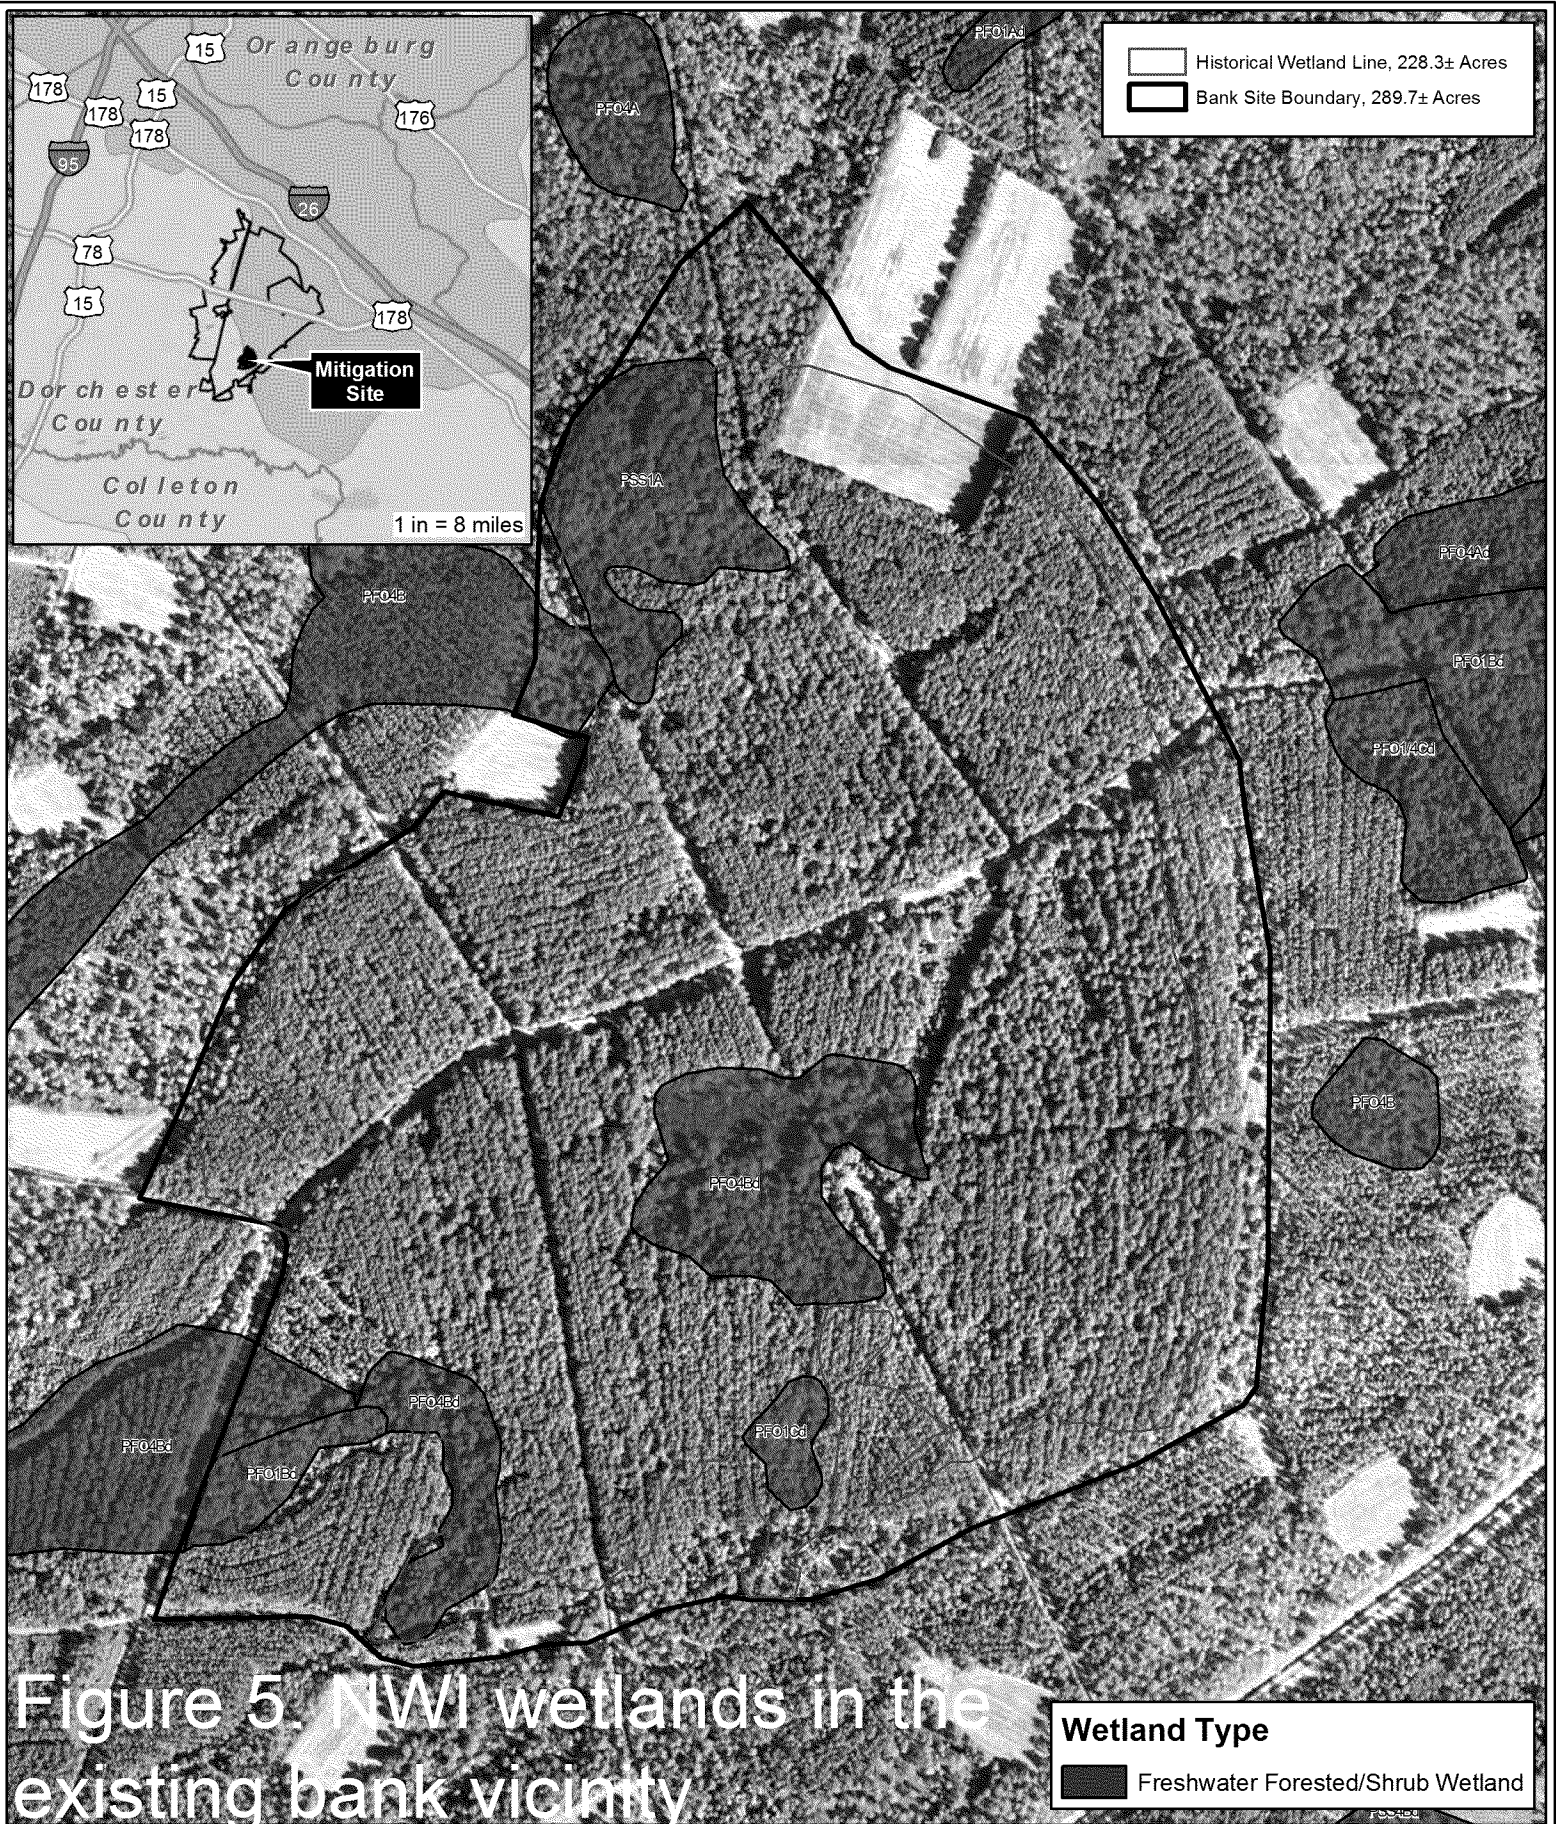
Figure 5. NWI wetlands in the existing bank vicinity

occur in the old stream channel, mainly close to the pocosin (Figure 5), but there is little to no natural function in the ditch channel. The 1938 aerial photo of the site (Figure 6) shows the stream system in a fairly intact state, meandering through the pine uplands as a broad shallow mostly herbaceous swale until it hits the upper section just below the railway, where it transitions to a forested hardwood swamp. By 1994 (Figure 7), it has been channelized for several decades and little of the stream system is visible. The middle reach (below the railway) has been impounded to create two permanent ponds that are managed by flashboard risers and a spillway on the north end. The lower reach, though deep and wide, receives a fraction of the water it historically moved and has become severely encroached. In 2016 (Figure 8), the stream system is primarily a ditch with a pond in the middle and a dry bottomland section north of the road. Brosnan Forest surrounds the proposed project entirely, with a conservation easement already in place held by Lowcountry Open Land Trust. Current land use is primarily recreation (hunting, fishing, buggy tours), food plots, sustainable timber harvest from natural longleaf pine uplands, some loblolly plantation areas. Uplands are burned regularly and the site supports numerous wildlife species, including a regionally important red-cockaded woodpecker research population.

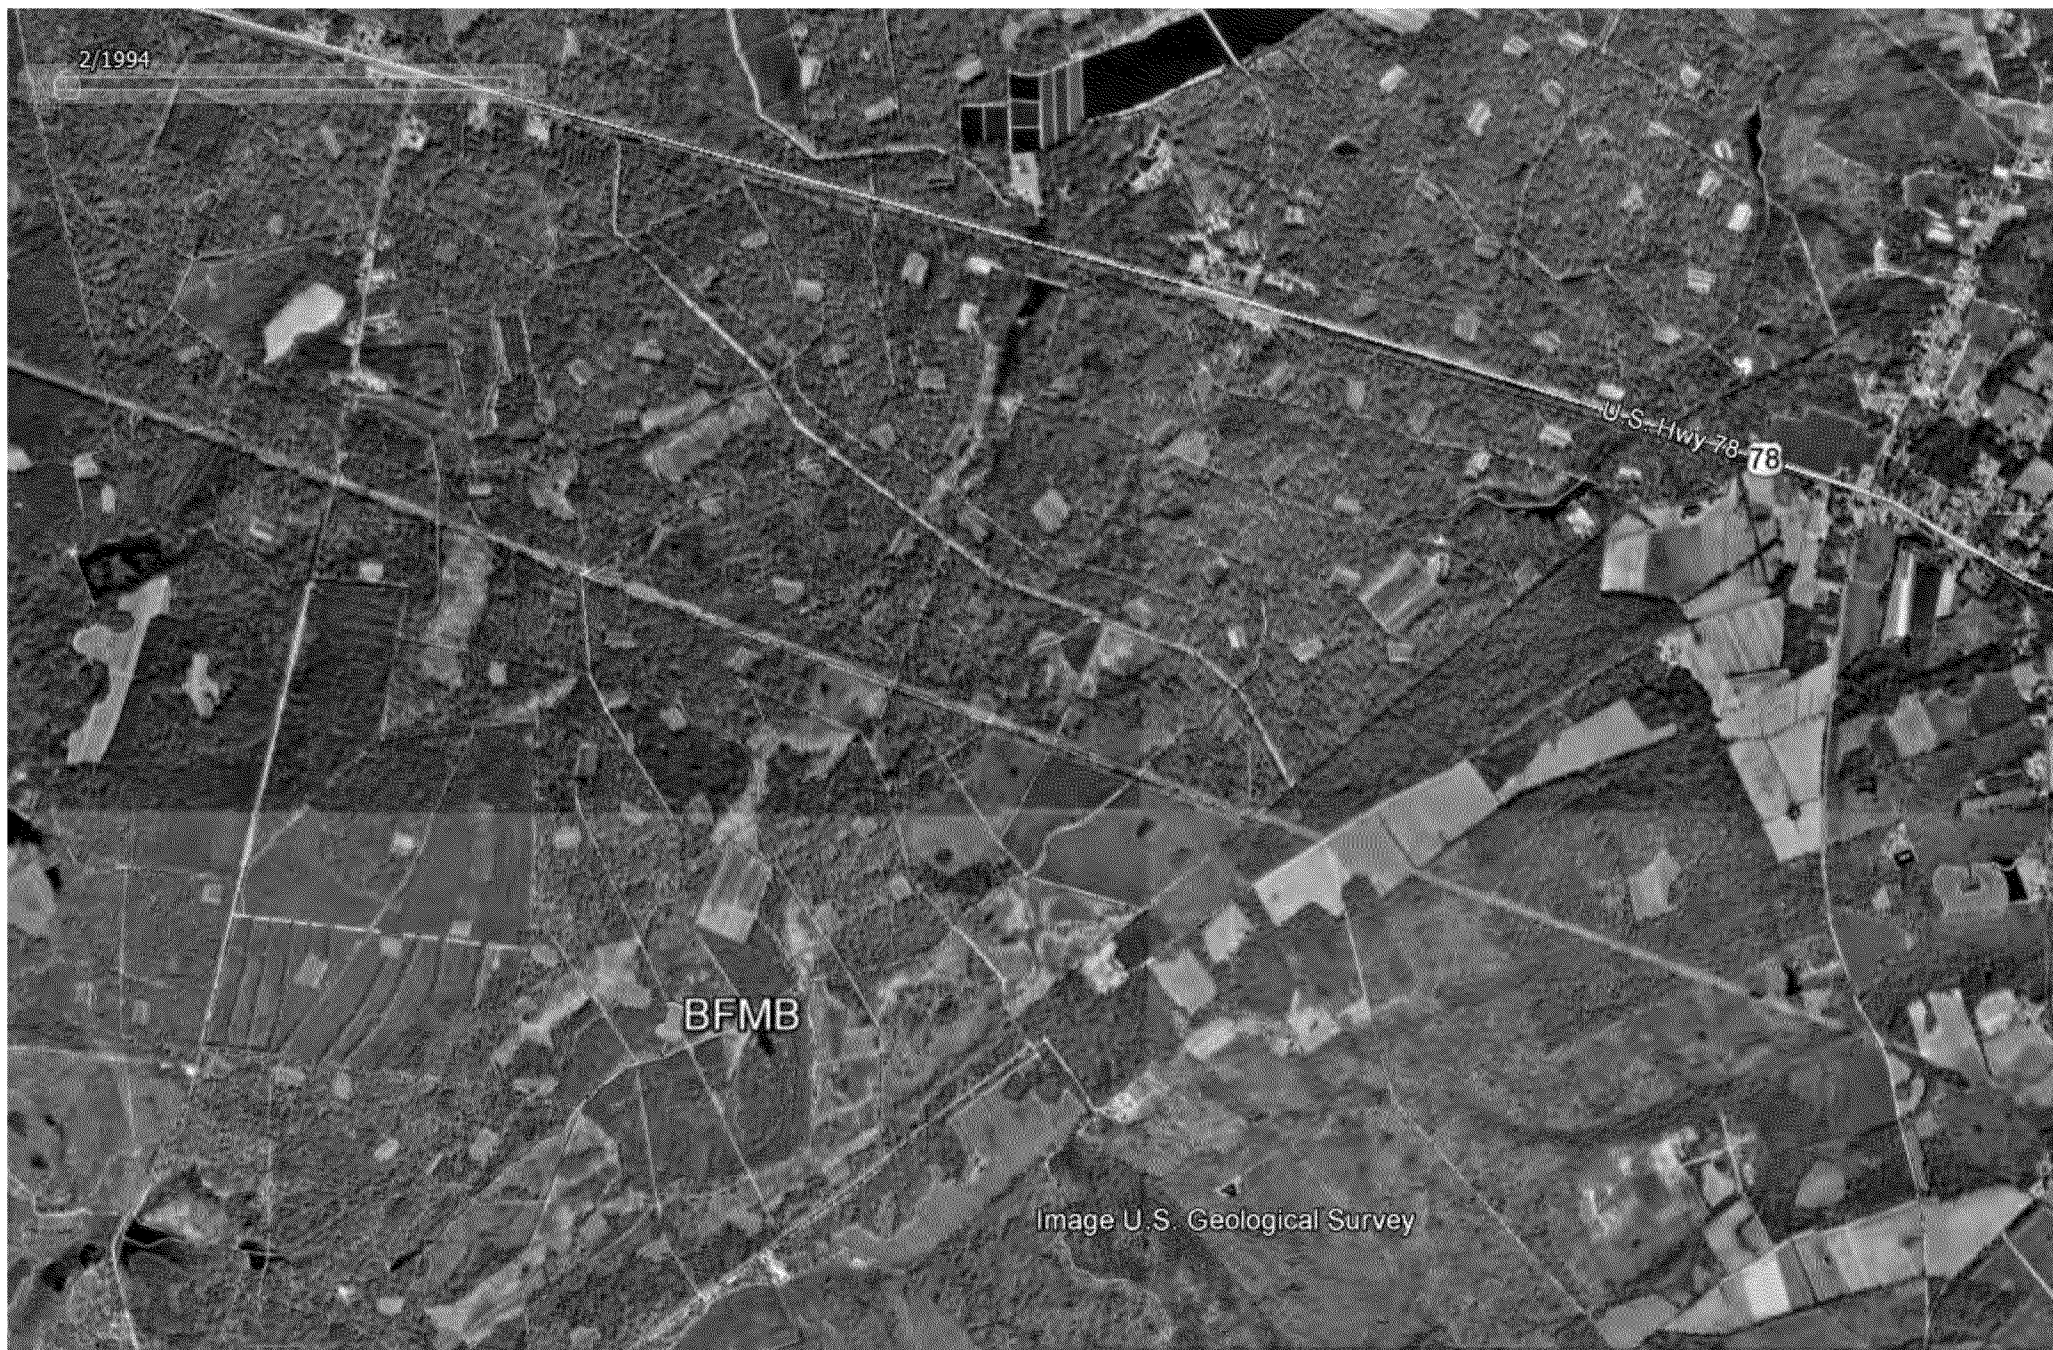
Figure 7. 1994 aerial of the proposed stream restoration project

Figure 7 is a 1994 aerial of the project

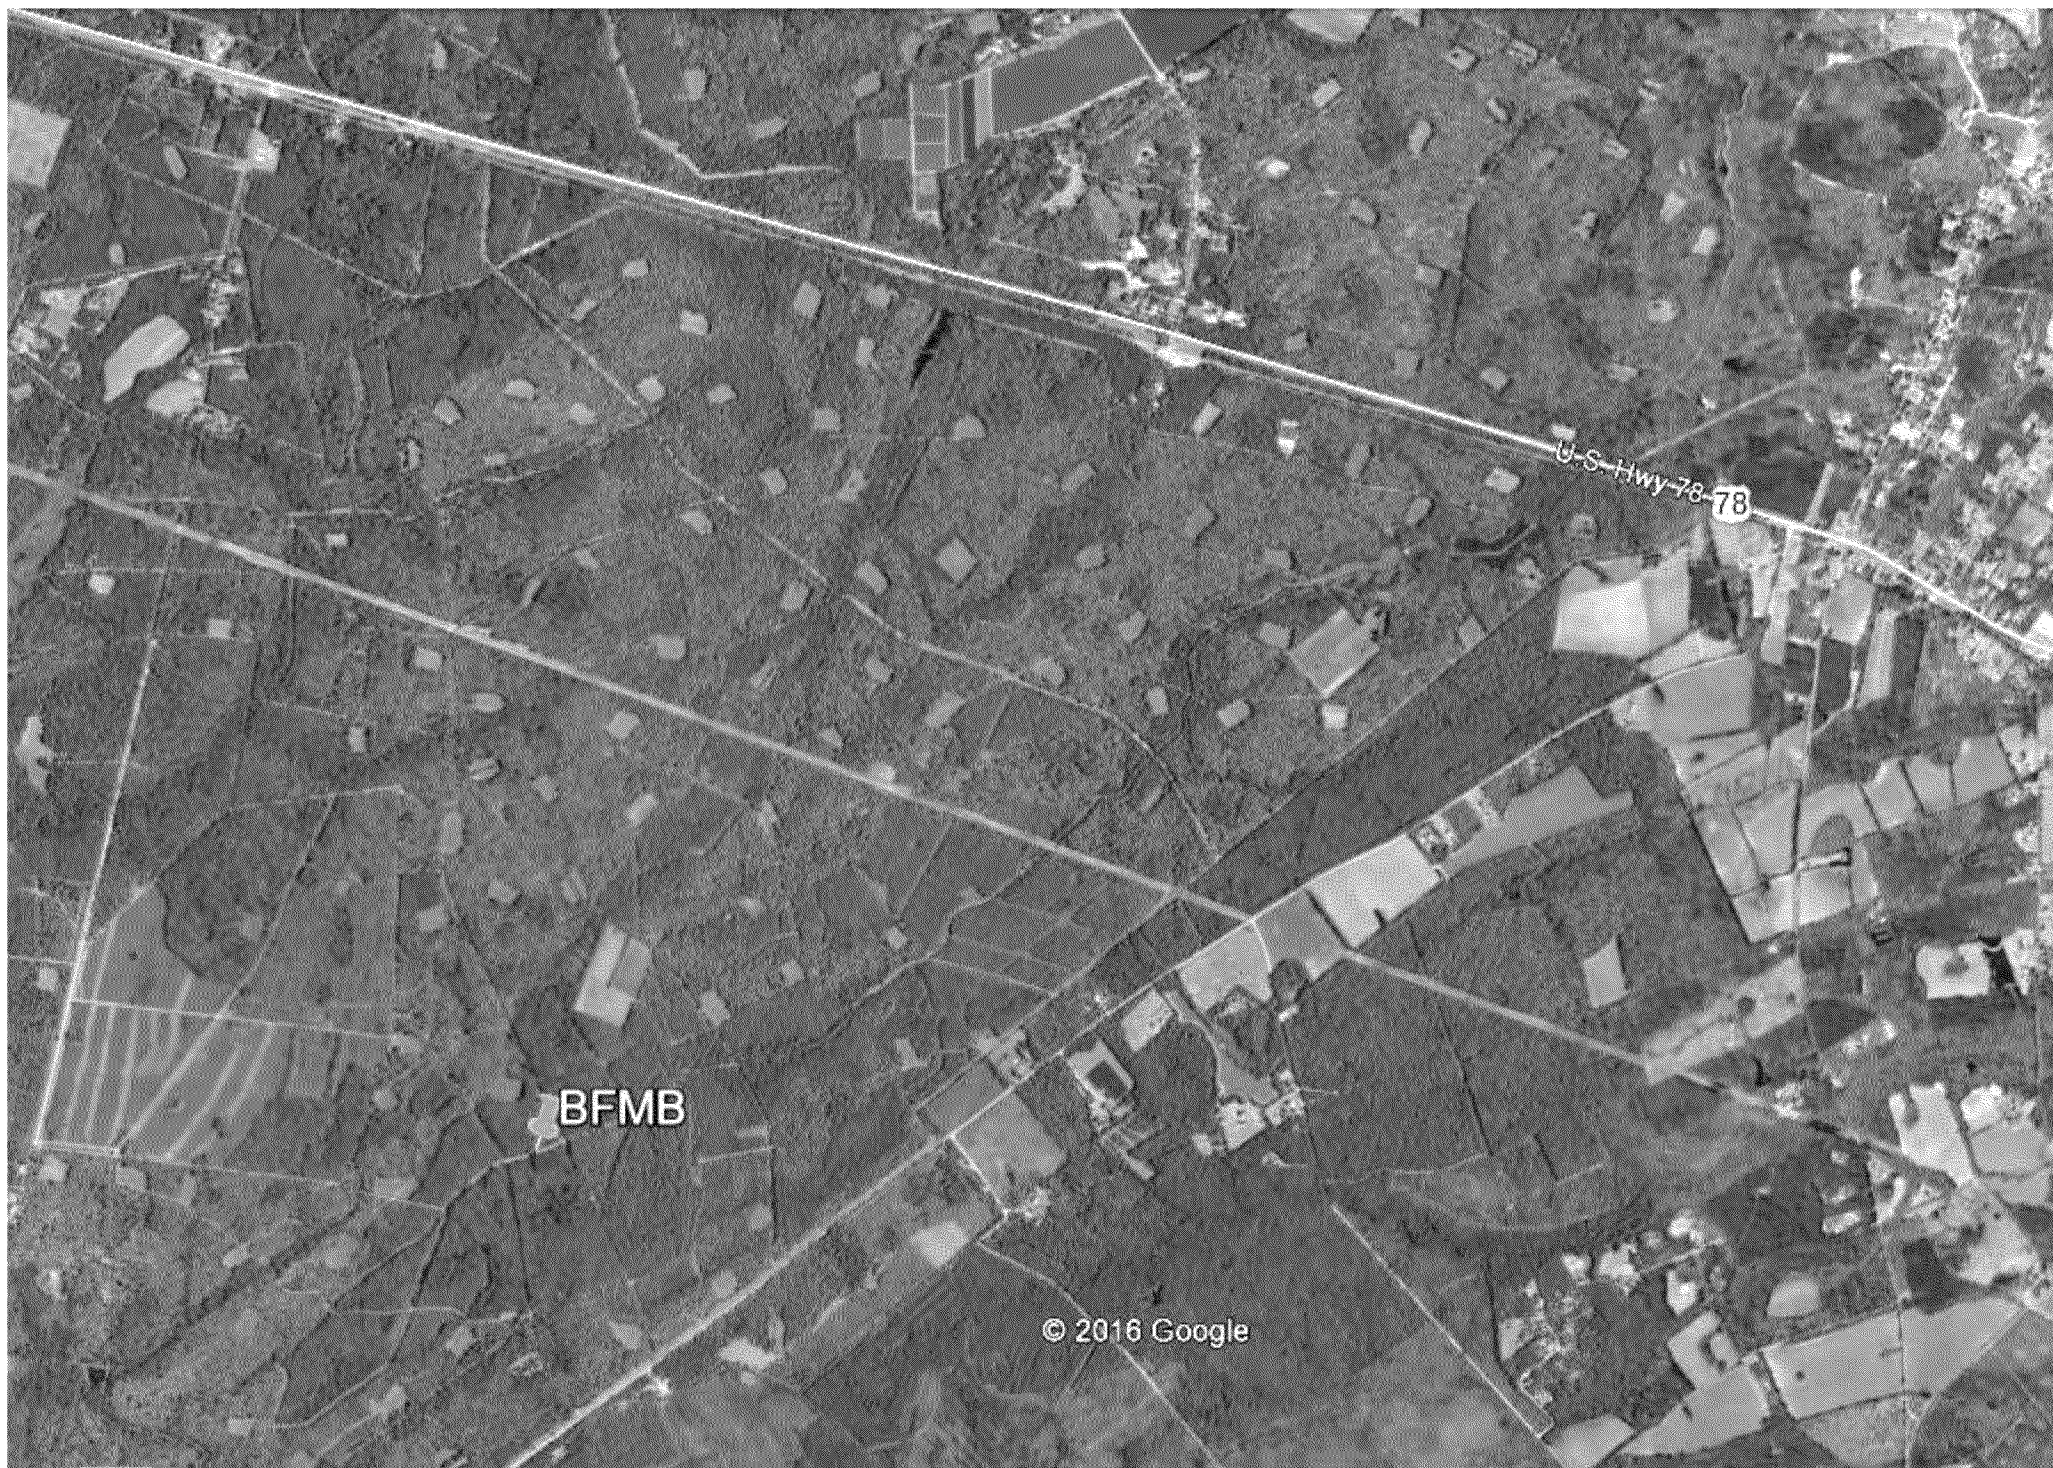
Figure 8. 2016 aerial of the proposed stream restoration project

At a point just north of the large powerline right-of-way, the stream changes character and becomes much steeper sloped, entrenched, more sinuous, with a wide forested floodplain (Figure 8). It maintains that character until it reaches the spillway just below the highway/railway, so we will treat that 1.5-mile section as the second reach (Figure 10). Embedded within this stretch are the two impounded ponds, which will be removed as part of the design. The final reach is the 1-mile section north of the highway. It consists of a large wide heavily encroached bottomland forest with a less-distinct channel, though that may be an artifact of the limited flow from the impoundments above. This stretch will be studied carefully before a final plan is made. For the last 0.4-mile portion of the creek, the sponsor controls only the left bank (property line runs with the creek channel).
